7 PRESERVATION BRIEFS

The Preservation of Historic Glazed Architectural Terra-Cotta

Technical Preservation Services Division

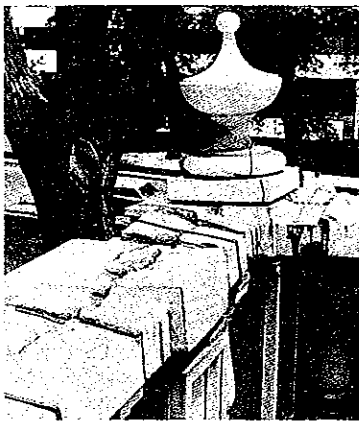
Figure 8. Deterioration of Exposed Detailing. Exposed or freestanding terra-cotta detailing (parapets, urns, balusters, etc.) have traditionally been subject to the most severe vicissitudes of deterioration as a result of freezing temperatures and water. (Colorado State Historic Preservation Office)
